## GEOTECHNICAL ASSESSMENT AND SAFE SLOPE DESIGN OF A LANDSLIDE IN A LIMESTONE QUARRY (ORDU/NE TURKEY)

**Abstract.** Limit equilibrium analyses have been carried out to investigate the stability of a limestone quarry near Unye (Ordu/Turkey) after a landslide that took place, and slope remediation studies were conducted to procure long-term stability. A 1/5000-scale geological map of the landslide was prepared through field measurements and topographic maps, and stability analyses were carried out on 4 different cross-sections along the slope. Factor of safety values as low as 0.8 were determined for one of the slopes for pseudo-seismic condition, therefore a stable slope design was created. The stability of the new design was also tested with limit equilibrium analyses and the results indicate the factor of safety values will remain above 1.3 even with the seismic effect.

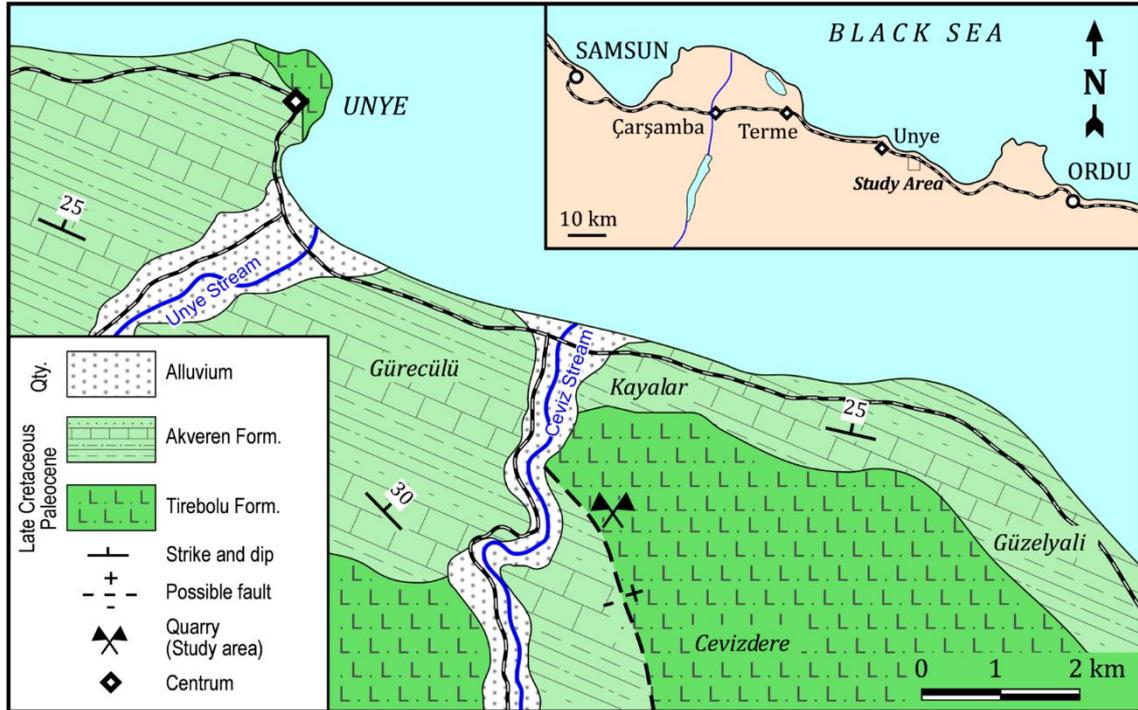
Fig. 1. Location and geological map of the study area

The study area, which is in the northern zone, is located in Cevizdere region of Ordu city, approximately 6 km southeast from Unye town center (Fig. 1). Andesite, dacitic tuff and bentonite clays (a residual soil formed by the weathering of dacitic tuff) of Late Cretaceous Tirebolu Formation are the base units in the area, which are conformably overlain by limestone, marl, siltstone and sandstone units of highly fossiliferous, Late Cretaceous Akveren Formation (Gedik & Korkmaz, 1984; Guven, 1993). Quaternary alluvium and marine terrace overlay other geological units in the area and cover most of the stream beds and Black Sea coast.

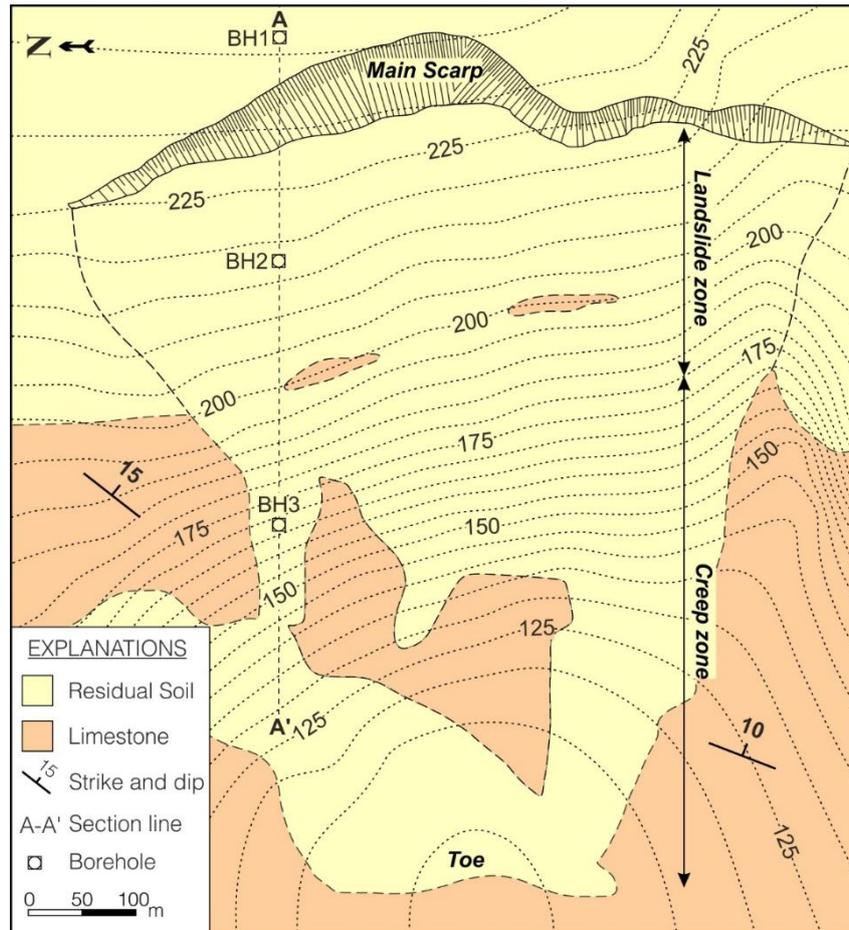
**Fig. 2.** Geological map of the landslide

The residual soil consists of 28% sand, 38% silt, and 34% clay-sized particles. Its liquid limit values vary between 63-76% and plastic limit values between 24-34%. Using Unified Soil Classification System, the soil was classified as CH, highly plastic inorganic clays. Main clay mineral in the residual soil is montmorillonite, a highly plastic and water susceptible material. The soil also contains small percentages of minerals like albite, calcite, quartz and gibbsite (Sünneci, 2015). The limestone unit is moderately jointed, and significant cracks oriented perpendicular (280/15) to the quarry face are present. The layers are parallel to the slopes, inclined 10-15° to the northeast. Stratigraphically the limestone unit is above the residual soil, yet in the study area it's exactly the opposite, which suggests a reverse-faulted contact between these units.

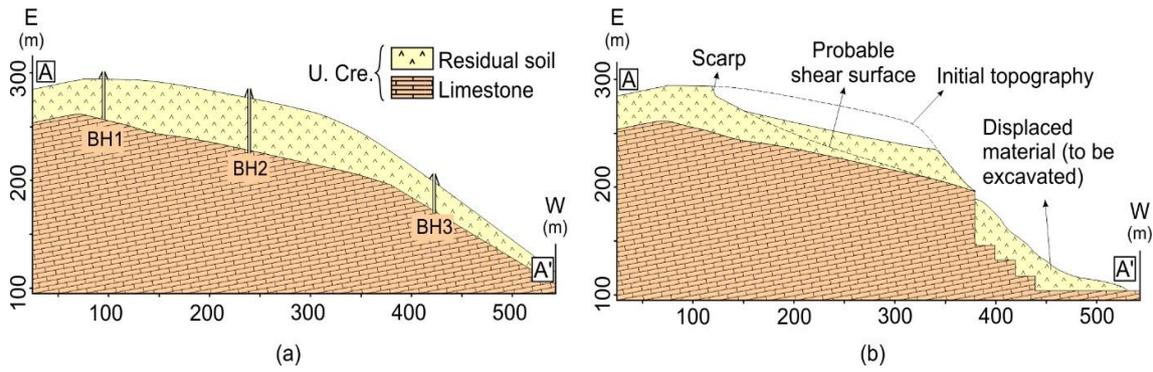
**Fig. 3.** A-A' cross-section before the production process in the quarry (a) and after the landslide (b)

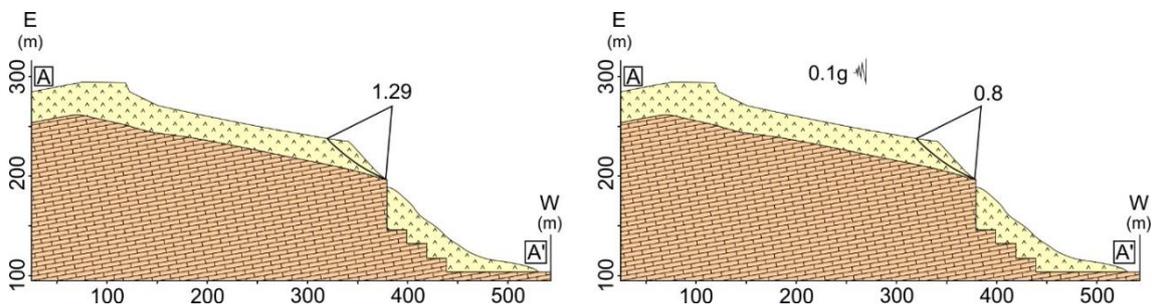
The results of the analyses indicate that there is a landslide risk with post-shear slope geometry along one of the cross-sections with seismic effect (Fig. 4).

Fig. 4. Post-shear stability analyses with (a) and without (b) seismic effect along A-A' cross-section

near the heel, where factor of safety drops to values as low as 0.8 for pseudo-seismic condition. To implement stability of the slope during the relocation of the displaced material and production in the quarry, new stable slope geometry has been designed. The stability analyses for the new design proved that the slope will remain stable, even in the event of an earthquake. The new slope design was applied to the slope in recent years, and no implications of a mass movement have been observed as of today (Fig. 7).

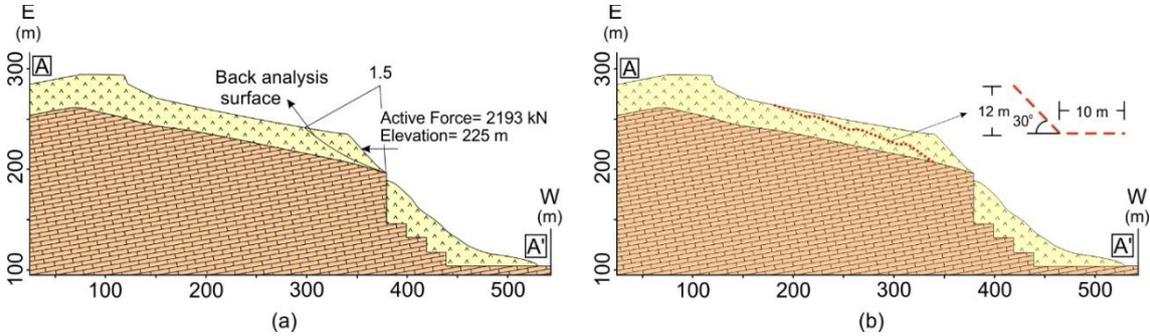
theslope. New slope geometry has been designed with Slide®6 software, using the back-analysis support design module of the software (Fig. 5). This module calculates the required counter-force on the slope surface for a given factor of safety (in this case 1.5).

**Fig. 5.** Support back-analysis (a) and new slope design (b) for the slope

As it can be seen from the Fig. 5, the required counter-force on the slope surface is 2193 kN for a factor of safety of 1.5. This is a relatively high force and building a retaining wall which can withstand such a force would be unsuitable for this project, where excavating is an application performed frequently. Rock bolts are an alternative support type, yet they must be socketed into the intact limestone which is the material that is being produced in the quarry. Also, the shear surface is at a depth of 15 meters at most, which is too much for practical use of rock bolts. For these reasons, slope remediation studies were centred on dividing the slope into smaller and gentler stable slopes. Considering both residual soil's physical-mechanical properties and the geometry of the slope, different new slope designs were created. Stability analyses for the new slope were carried out both with and without seismic effect to assess long-term stability (Fig. 6). The results indicate that the factor of safety value of the new slope would be above 1.3 even with the seismic effect.

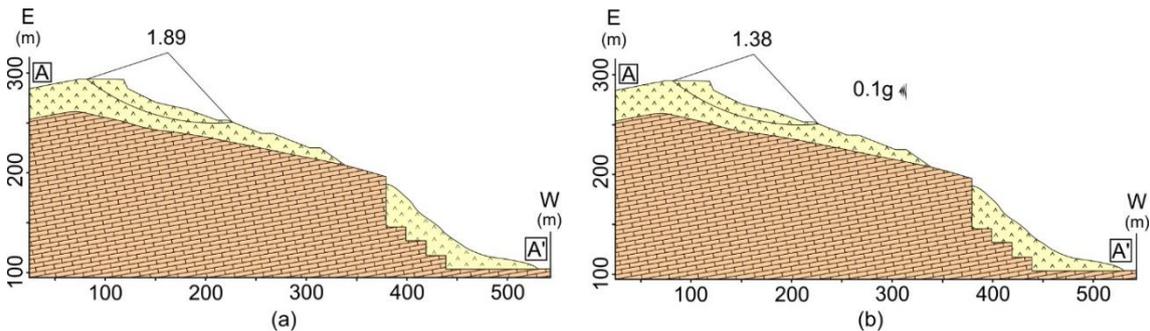
**Fig. 6.** Stability analyses with (a) and without (b) seismic effect for the new slope geometry

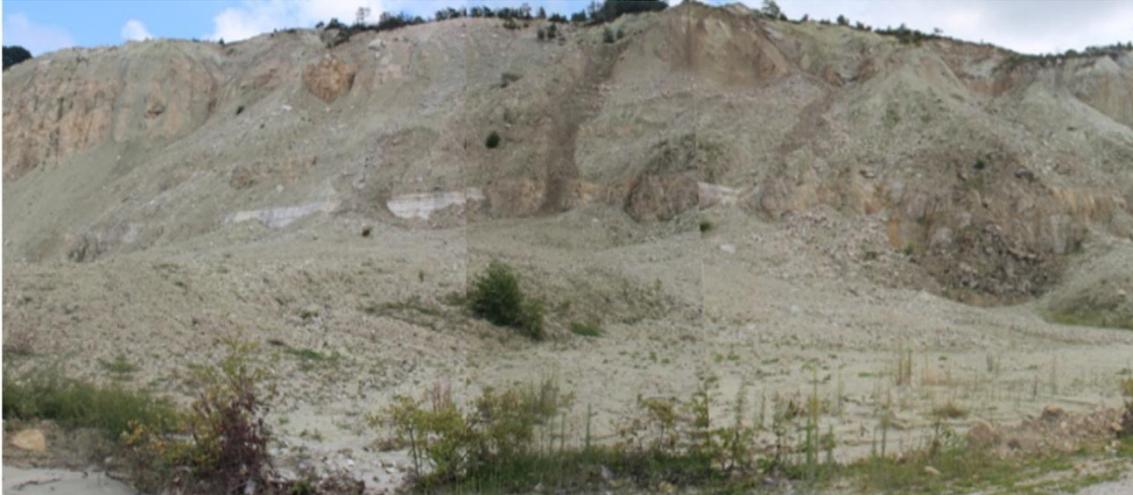
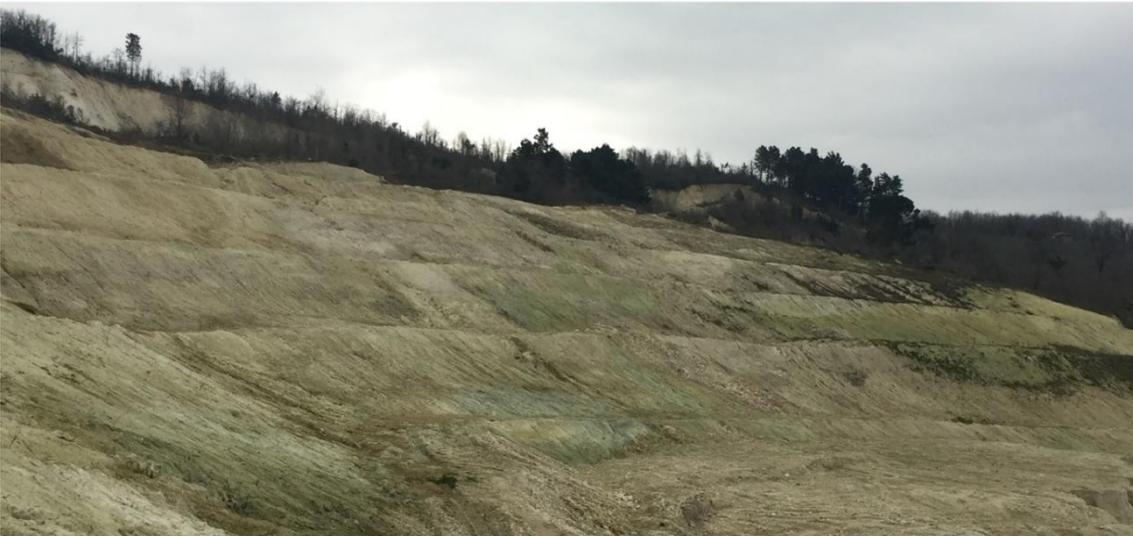
**Fig. 7.** The view of the slope before (a) and after (b) the remediation studies
