INVESTIGATION INTO TORSIONAL FAILURE OF AUTOMOBILE CRANKSHAFT

Abstract. The failure of crankshaft is a severe problem faced in the automobile industry. Most of the fracture is attributed to fatigue failure. Fatigue phenomenon is very difficult to understand and analyse and can be treated as an extremely important challenge to be addressed. In avoidance of the complex physical dimension of crankshaft, this study provided a simplified method of predicting fatigue life using tensile strength induced by torsional loads on the crankshaft. Investigation showed that dynamic load on rotating system had caused twisting and bending that had affected not only the mechanical properties but also the microstructure of the crankshaft material. The effect had translated to increased brittleness of the material and invariably led to sudden failure of the crankshaft below the yield strength. Proactive preventive maintenance measures were proposed for sustaining the service life of the crankshaft.

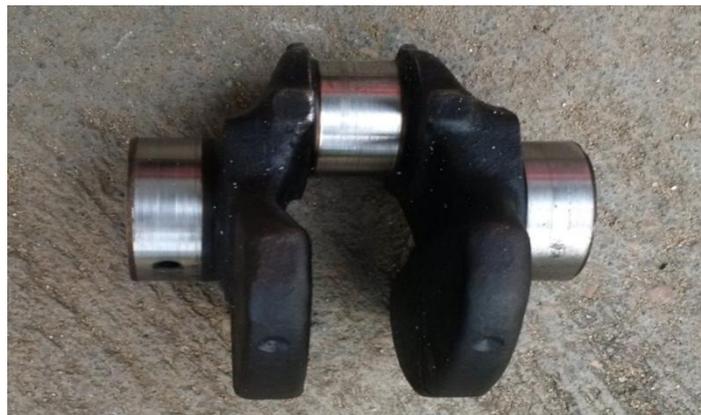
Figure 1. Specimen A showing the failed crank pin journal

Geometry measurement of the failed crank-pin, using a micrometre screw gauge shows a reduction in diameter of the pin. Diameters Ø47.8 and Ø47.2 were recorded for specimen A and specimen C respectively as against specimen B (Ø48) as standard control specimen. This indicates that wearing occurred most in specimen C. This may be attributed to poor lubrication of the engine. Poor lubrication cause excessive load as the system run under heavy friction. Table 2 shows the summary of tensile test result carried out using a 20kN capacity HSM58 Universal material tester. Result shows that specimen C had the highest strength as also supported by the higher Brinell number (Tables 2 and 3) which is quite the reverse for the metallography result as depicted on the micrograph (Fig. 8). The micrograph in Fig. 8 indicates a porous and homogeneous view of the microstructure matrix of the material. This may be attributed to cold deformation of the crankshaft. The micrograph of specimen A (Fig. 6) shows deformation lines and a deformed structure where one can no longer view the grain structure which is apparent in specimen B (Fig. 7). The micrograph in Figure 7 shows the presence of inter-metallic nucleating at the grain boundaries and within the grains.

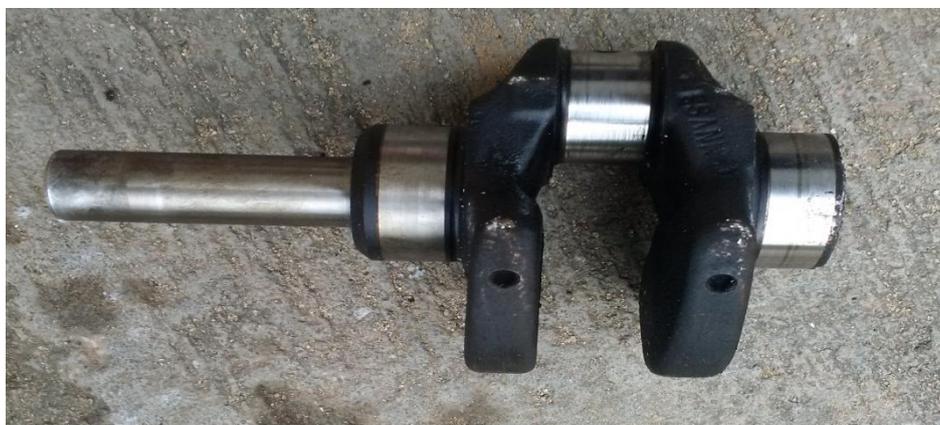
Figure 2. Specimen B showing the good crank pin journal

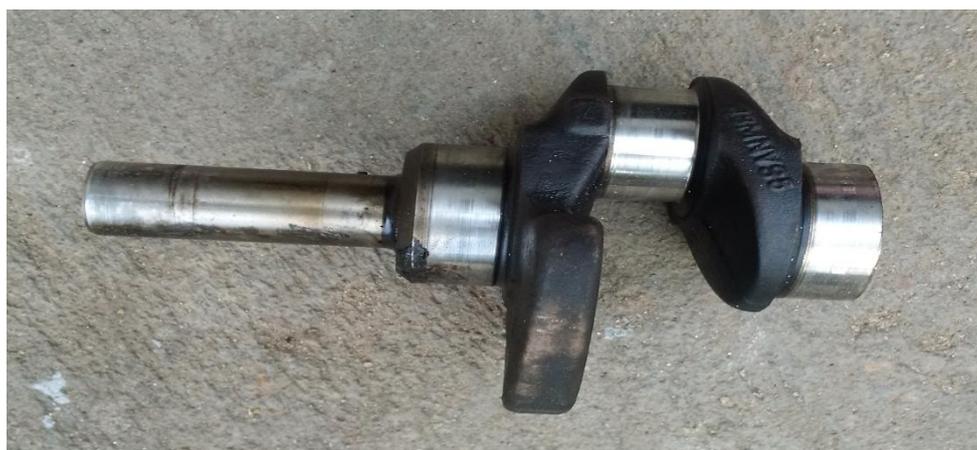
Figure 3. Specimen C showing the failed crank pin journal

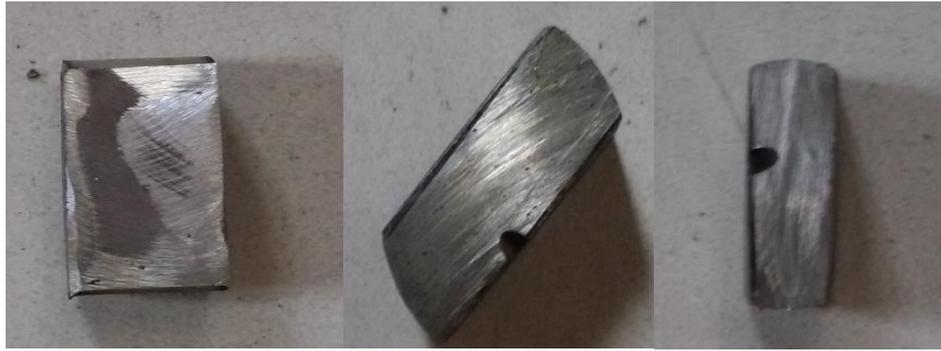
Figure 4. Samples machined out from the crank-pins
